6th EuroGeo Conference
25 - 28 September 2016
Ljubljana - Slovenia

Geomembrane systems in The Netherlands and abroad risks and lessons-learned

R.H. (Rijk) Gerritsen
Witteveen+Bos Consulting
Engineers, The Netherlands

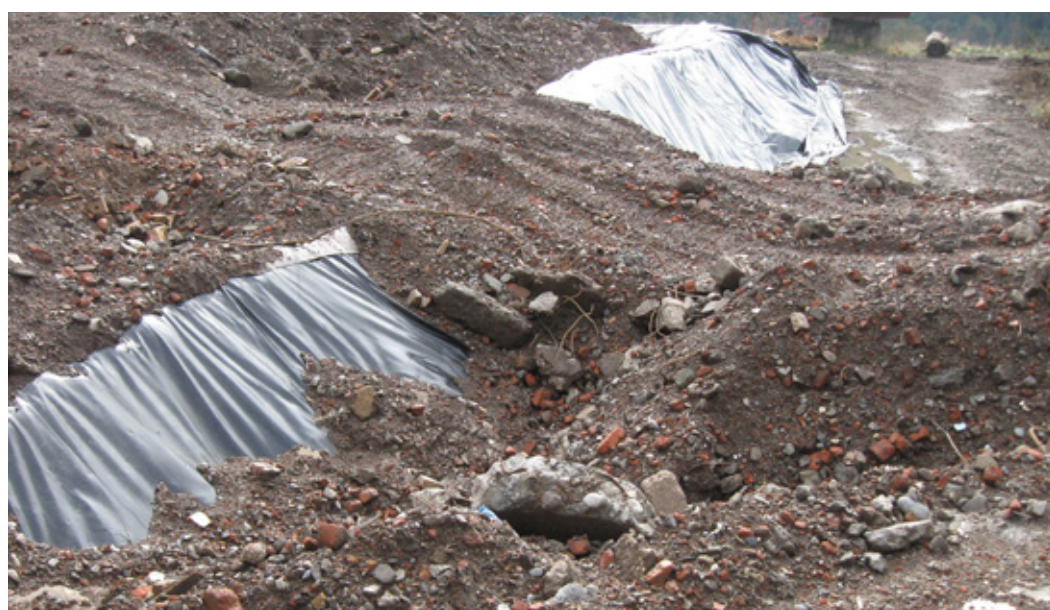
Figure 4 - The presence of sharp/big stones without protective geotextiles will significantly increase the risk on damaging the geomembrane [Gerritsen]

assessed that about 20% of the leaks occur at seams (improper welding), but over 70% (!) of leaks occur when the liner is covered by soil or stone. Based on these values and practical experiences the quality of groundwork's is showing a factor which is under-estimated in a lot of projects. The covering operation has to be seen as a very critical stage for the geomembrane. Related to this issue many examples in projects are known, observing unacceptable circumstances during the excavation or covering stage (see figure 4).

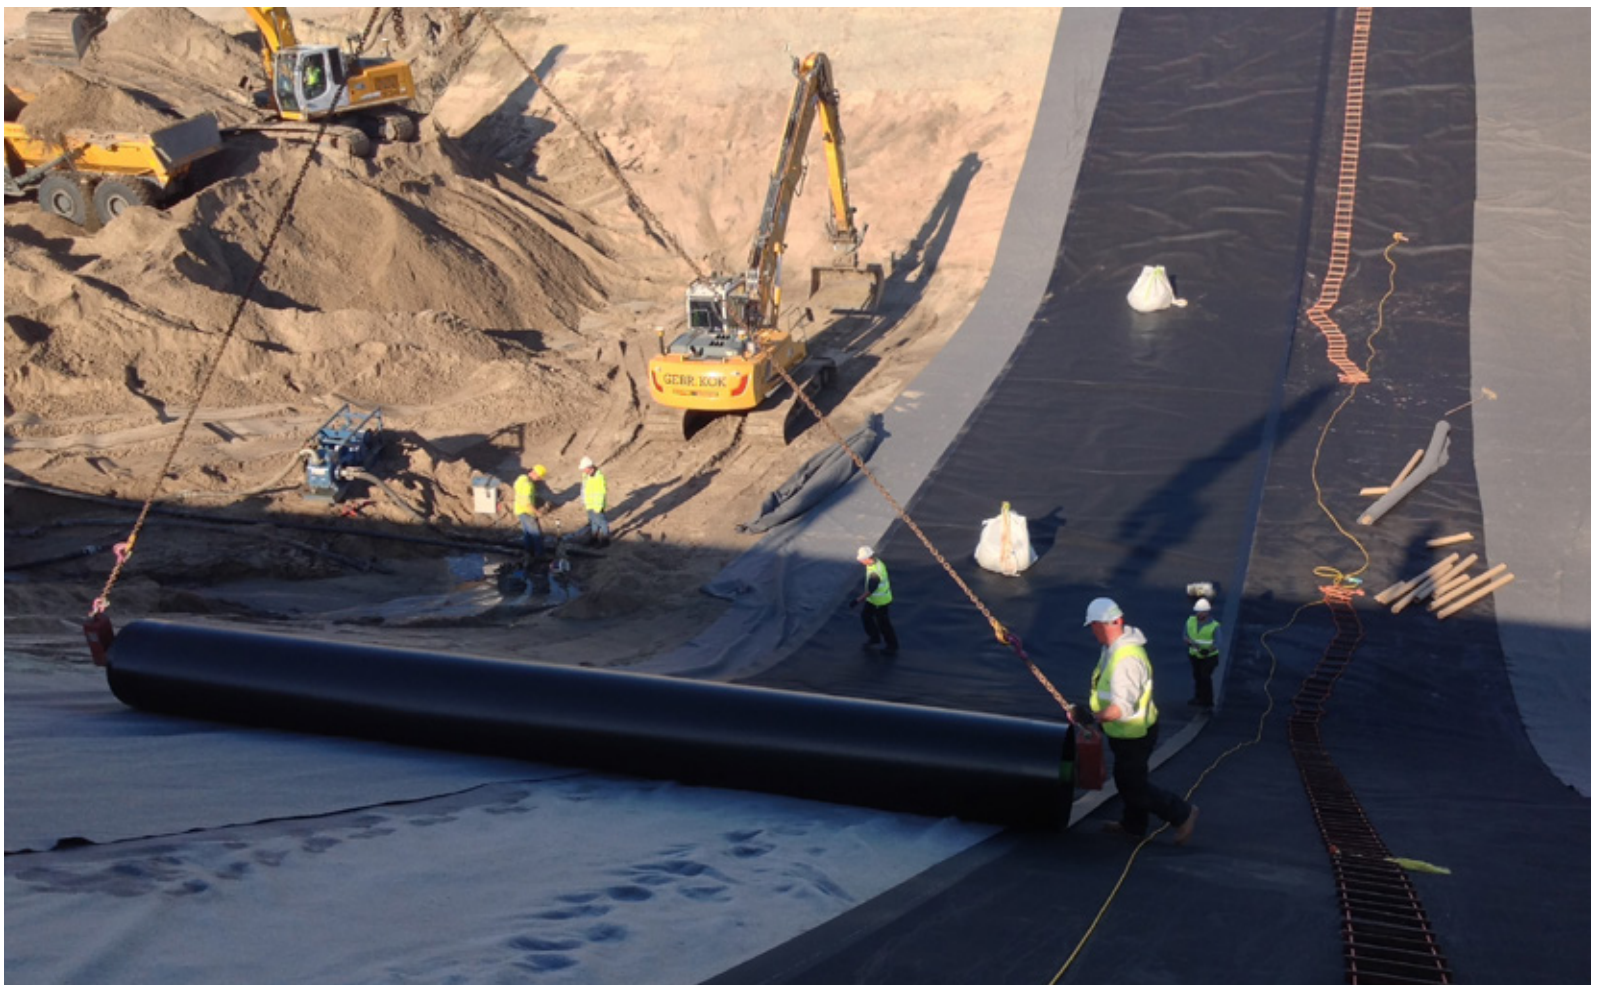
Figure 5 - Example of proper installation using a protective non-woven geotextile at the subsoil and topside of the geomembrane, working sequence with excavation works and installing method at large slopes [Gerritsen]

The subsoil on which the geomembrane will be installed needs also to be clear from sharp subjects which may puncture through the geomembrane. Measures can be taken for additional protection of the geomembrane. Since 2012 state-of-art geomembrane applications in The Netherlands are provided with protective non-woven geotextiles on both sides (bottom/above), see figure 5. In case of non-woven protective geotextiles attention should be given to the material type (polypropylene / polyester), minimum density, dynamic cone drop resistance and static puncture resistance. Applying a good quality non-woven will reduce the risk of perforations of the geomembrane significantly.
