SUBMERGING HIGH RESISTANT GEOMEMBRANES AS CONTAINMENT BARRIER CLOSURE DAMS BAKU - AZERBAIJAN

6th European Geosynthetics Congress

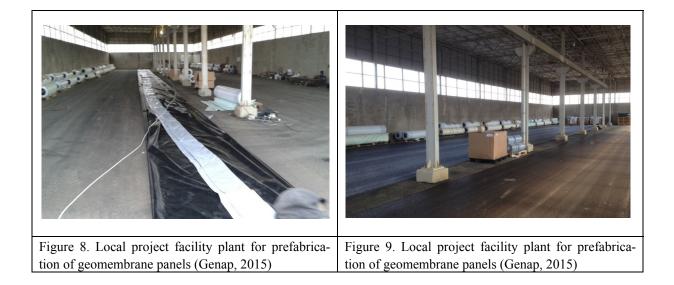
Full rolls of high resistant geomembrane , manufactured in the USA were shipped directly to Baku. In Baku the installation and prefabrication company Genap used a local building as pre-fabrication plant. The so called mother rolls of the geomembranes were prefabricated to obtain large sheets to the desired dimensions of embankment slopes. The prefabrication was done in a local project facility plant using rolling and unrolling equipment including cutting and welding devices. In the prefabrication hall welding was done by the hot wedge method (machines with one hot wedge). From the plant panels with a surface of approximately 1400 m² were prefabricated (length 70 meter versus about 20 meters width), packaged and transported to the closure dam for submerging on site. At the front of each panel Genap welded a floating air tube. This air tube kept the prefabricated panel floating during the process of submerging.

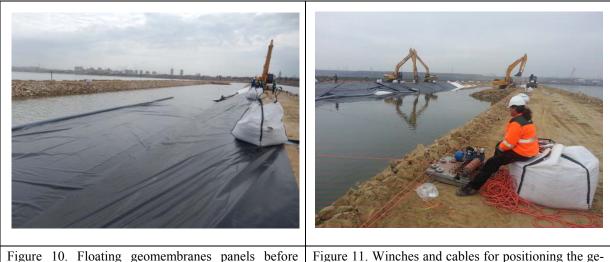
Figure 10. Floating geomembranes panels before
submerging under water (Witteveen+Bos supervision
staff, 2015)Figure 11. Winches and cables for positioning the ge-
omembrane panels (Witteveen+Bos supervision staff,
2015)

The subsoil of the embankments was prepared by grading and levelling to a surface which was most appropriate knowing the circumstances. At the subsoil a non-woven geotextile was installed (1000 gram/m²) to minimize the risk of damaging the geomembrane by sharp stones or irregularities from the embankment. After installation of the protective geotextiles the pre-fabricated geomembranes packages were placed on the top of the dam by a wheel crane and deployed by unrolling the package. Ballast bags keep the membrane in place and ensure that the membrane is wind fixed. To pull the membrane on the water surface ropes are installed from the membrane through pulleys that are attached to the temporary anchor poles and back to a winch on the Dam. After filling air tubes in front and on the side of the sheets the winch will pull the membrane slowly and tightly over the water surface (see figure 10 and 11).
